Case study: Facing inherited degradation and restoration concepts

San Simon Valley, Arizona, USA

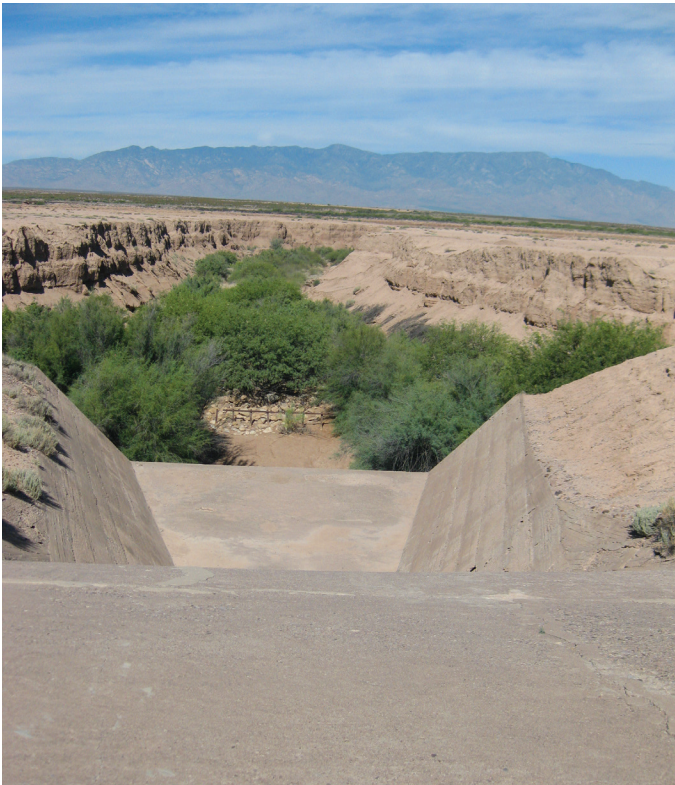
☛☛☛ Concrete goat well drop structure. This structure transports run-off from the upper, undissected fan surface down to the current stream course, effectively stopping headward erosion. Source: Brandau, W.

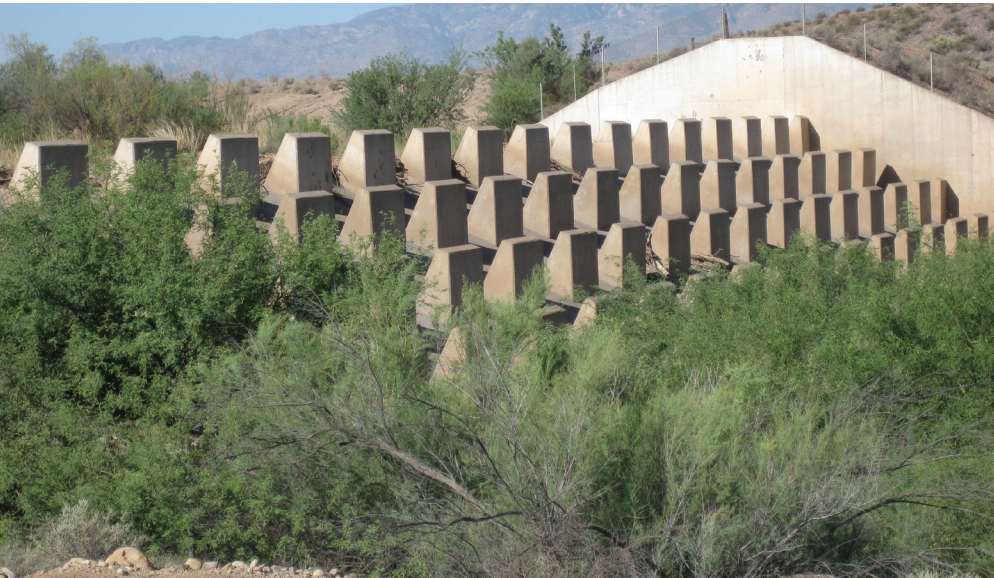
☛☛☛ Concrete barrier dam in the lower San Simon valley. Source: Brandau, W.

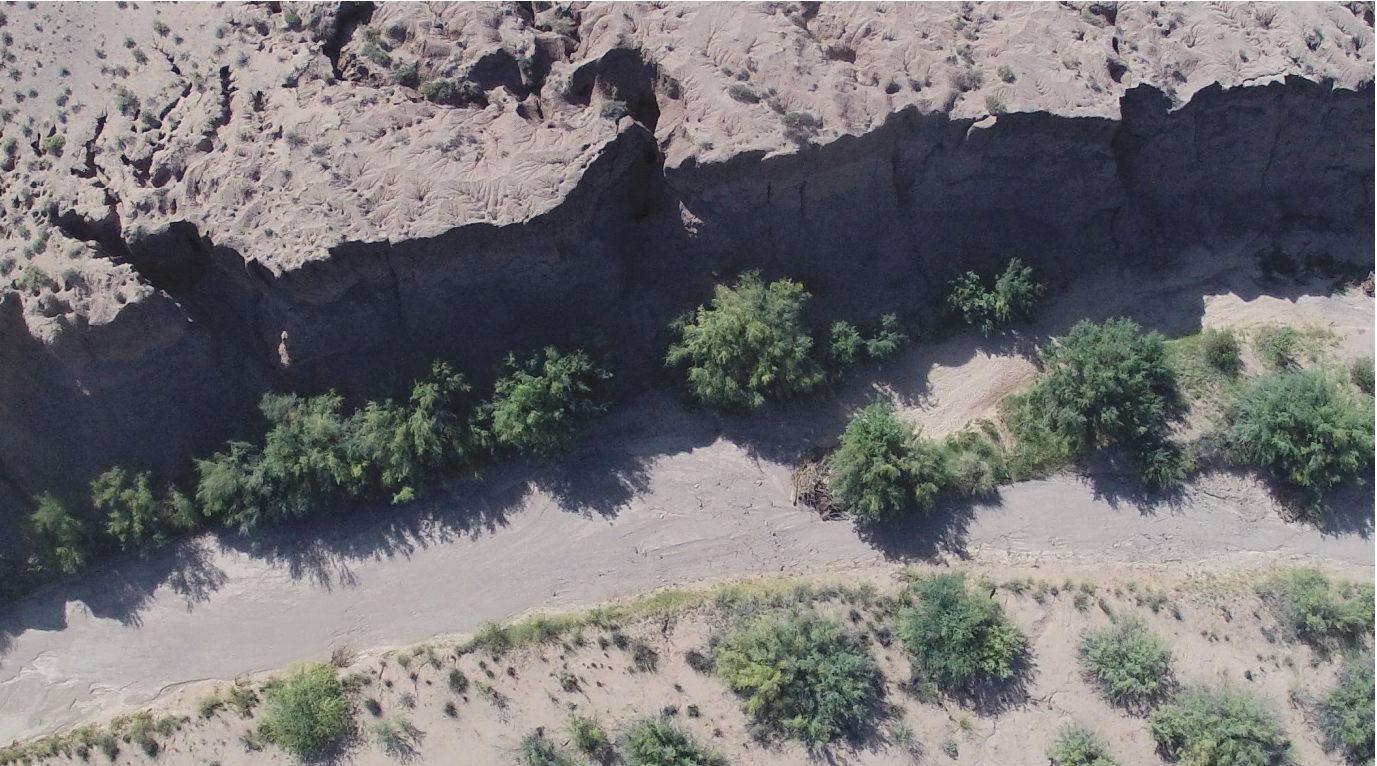
⋯. Erosion channels/arroyo cutting in the lower San Simon valley captured by an unmanned aerial system (RQ-11a Raven, 2012).
Source: United States Bureau of Land Management.
